ENVIRONMENT & INFRASTRUCTURE, INC
2533 Greer Road, Suite 6
Tallahassee, Florida 32308

PHOTO DOCUMENTATION – 1/20/2012
SHADD PROPERTY & VICINITY
220 WEST MAIN STREET
LAKE BUTLER, UNION COUNTY, FLORIDA
FDEP FACILITY ID NO.: 63 9807182
MACTEC PROJECT NO.: 6090110001

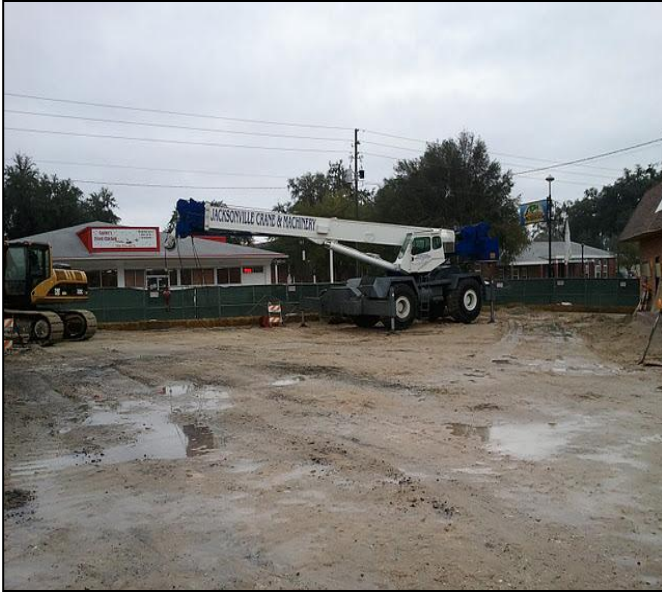
Photograph 1: Heavy rain occurred 1/17/12. No work was conducted other than checking stormwater controls.

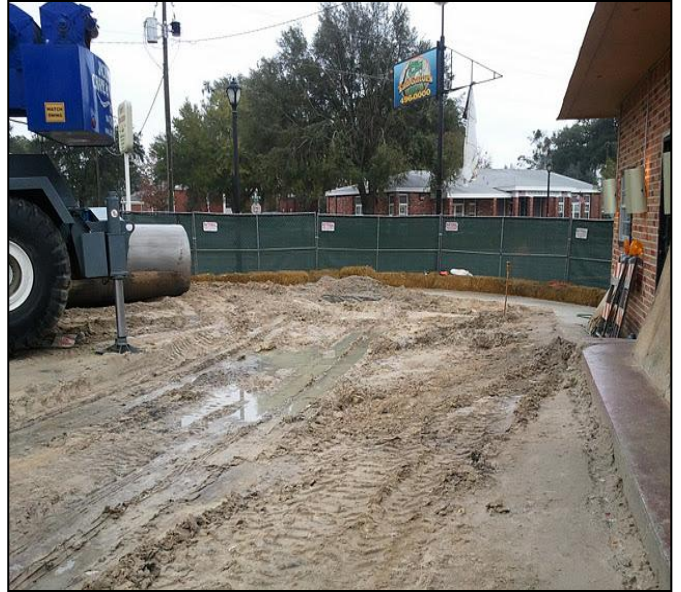
Photograph 2: rain water pooling in equipment tracks.

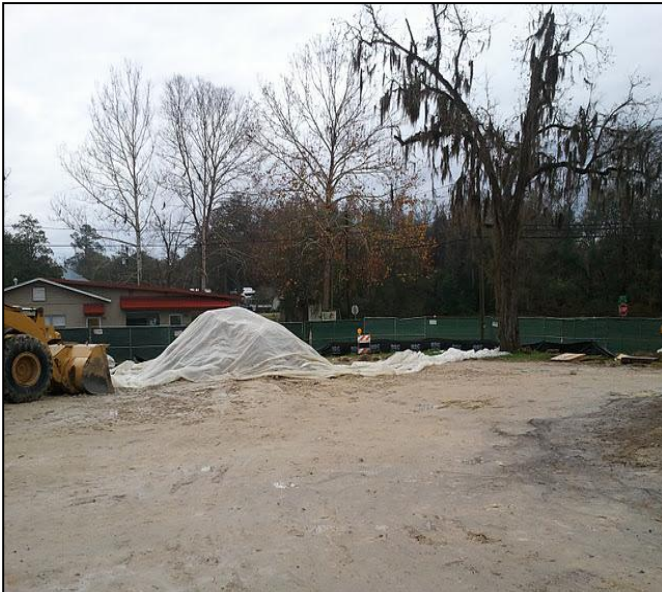
Photograph 3: Contaminated soils not directly loaded and removed were covered with plastic.

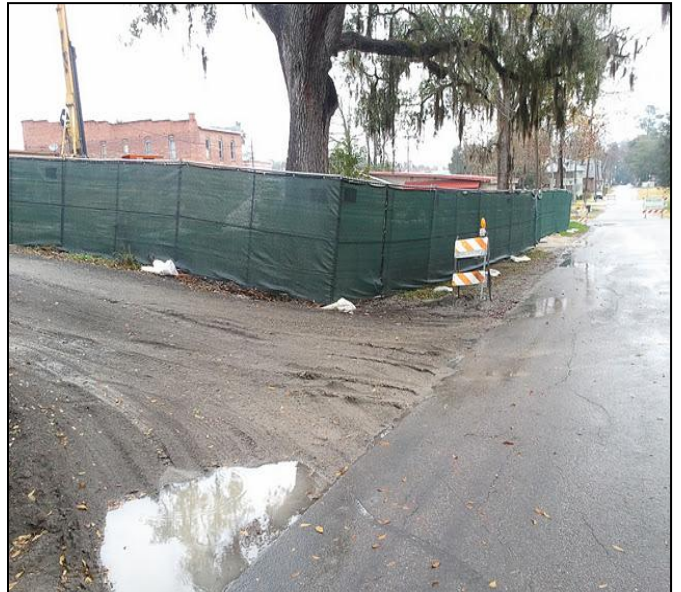
Photograph 4: Stormwater controls worked well to prevent sediment runoff on to 1st Street.

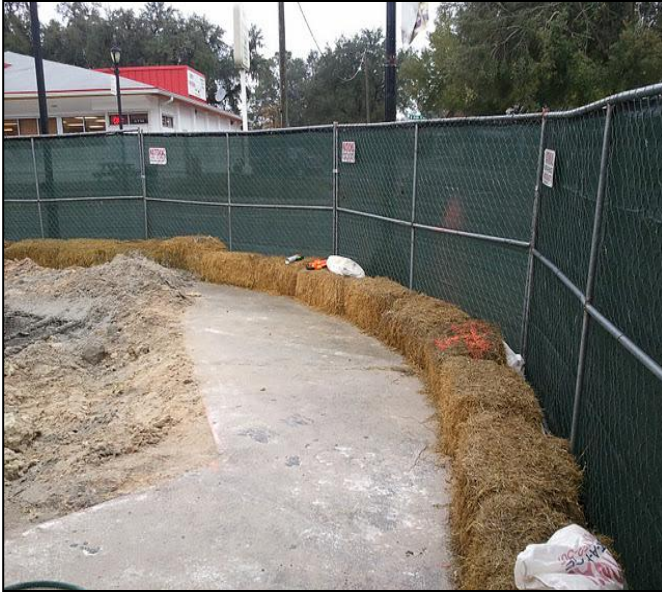
Photograph 5: Stormwater controls at the corner of Main Street and 2nd Avenue. .

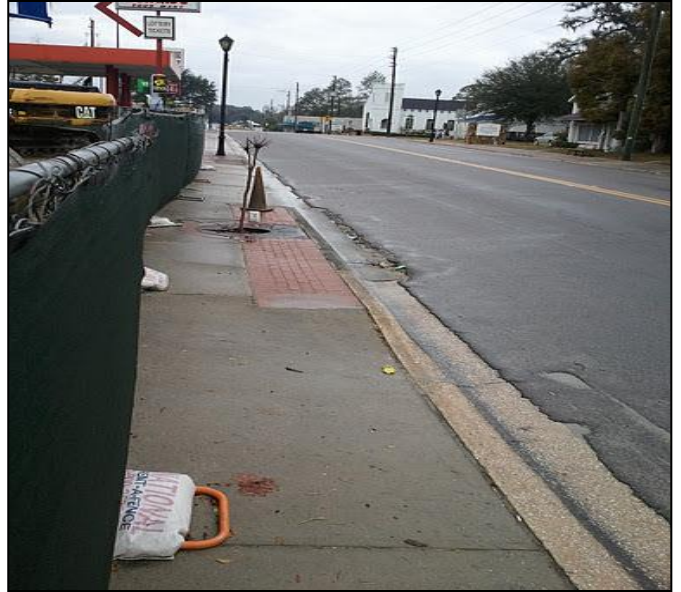
Photograph 6: Street side of the excavation on Main Street.

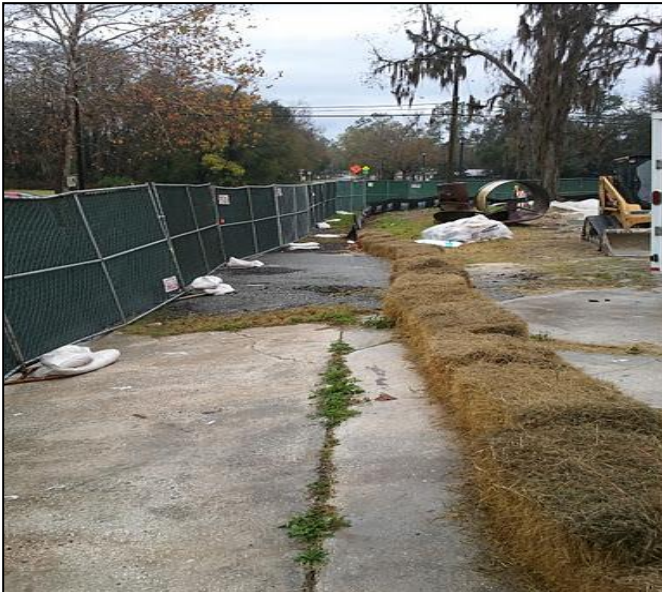
Photograph 7: Stormwater controls on 2nd Avenue.
