**ENVIRONMENT &
INFRASTRUCTURE, INC**
2533 Greer Road, Suite 6
Tallahassee, Florida 32308

PHOTO DOCUMENTATION – 12/16/11
SHADD PROPERTY
220 WEST MAIN STREET
LAKE BUTLER, UNION COUNTY, FLORIDA
FDEP FACILITY ID NO.: 63 9807182
MACTEC PROJECT NO.: 6090110001

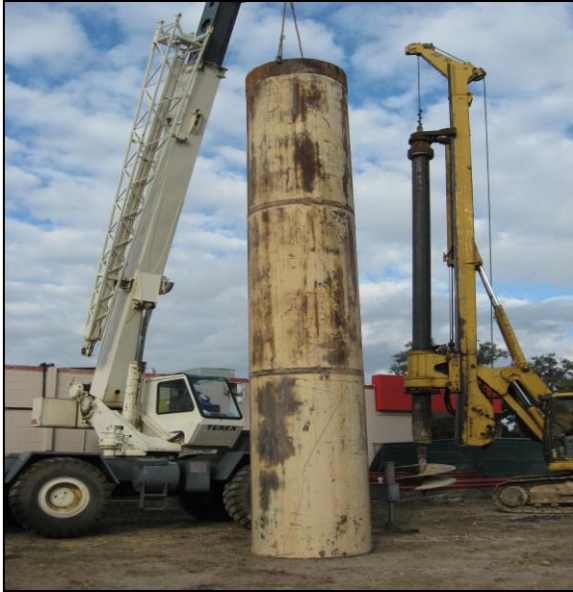
Photograph 1: 30-foot LDA casing with crane for casing the LDA holes from 20 to 28 feet bls.

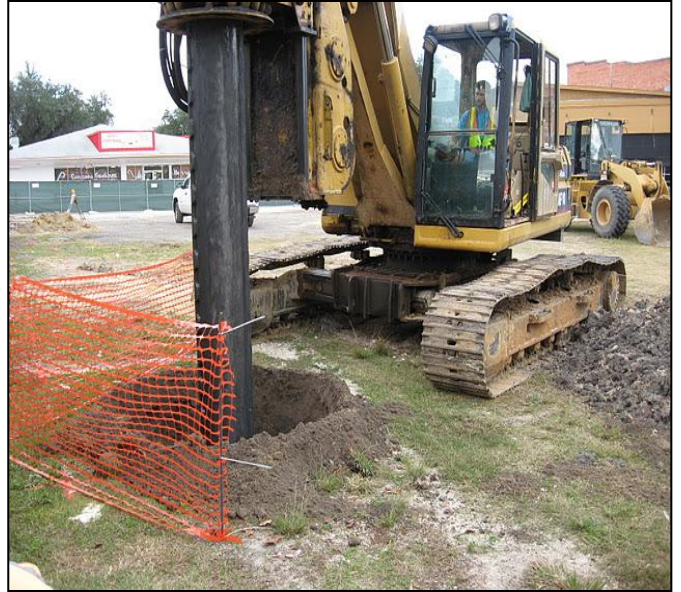
Photograph 2: Each boring was drilled to 20 feet with a traditional LDA rig with 5-foot dia auger.

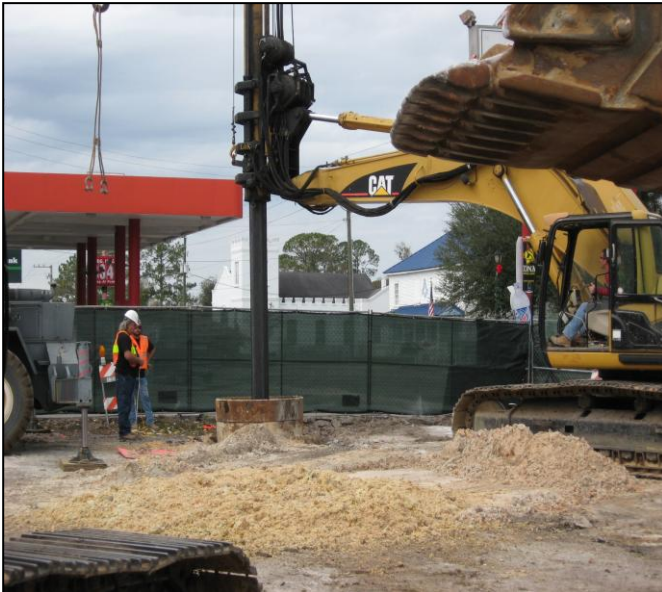
Photograph 3: After the casing is lowered into the boring a Lo-drill rig with a 58-inch auger is used to reach over the 10 feet of exposed casing and finish the boring to 28 feet bls. The casing self advances with the boring.

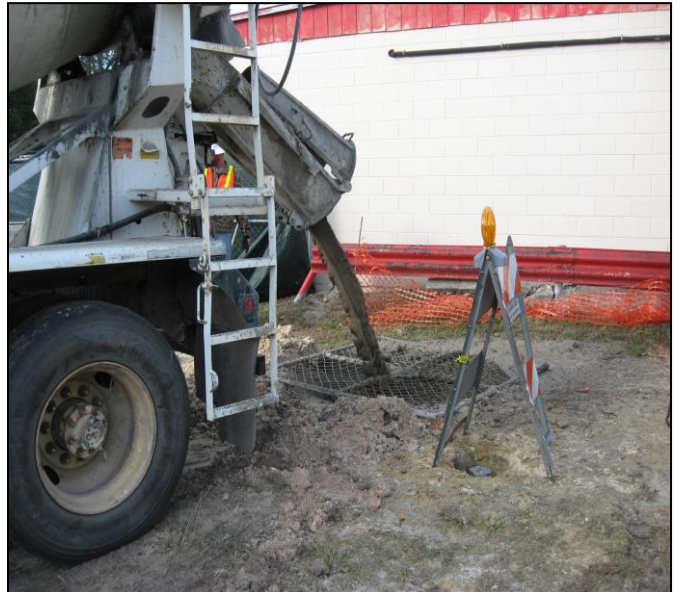
Photograph 4: Once the borings are completed they are back filled with self compacting flowable fill. Fill is poured through a reinforced fence section for safety.

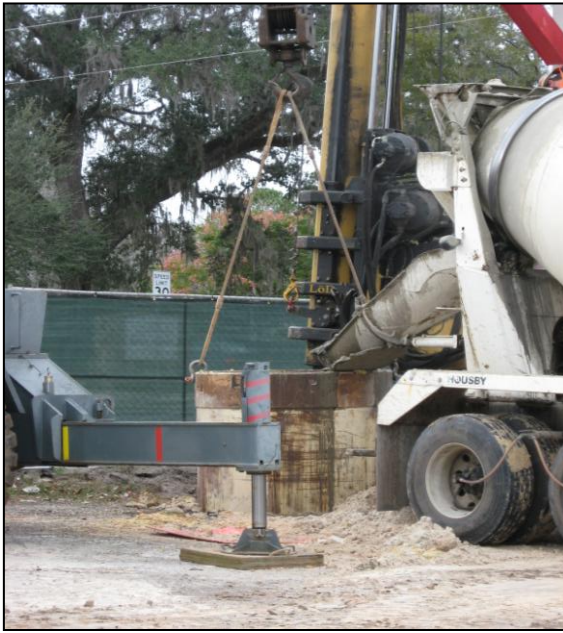
Photograph 5: Fill is added to the boring as the casing is removed to ensure that the formation does not flow into the boring void.

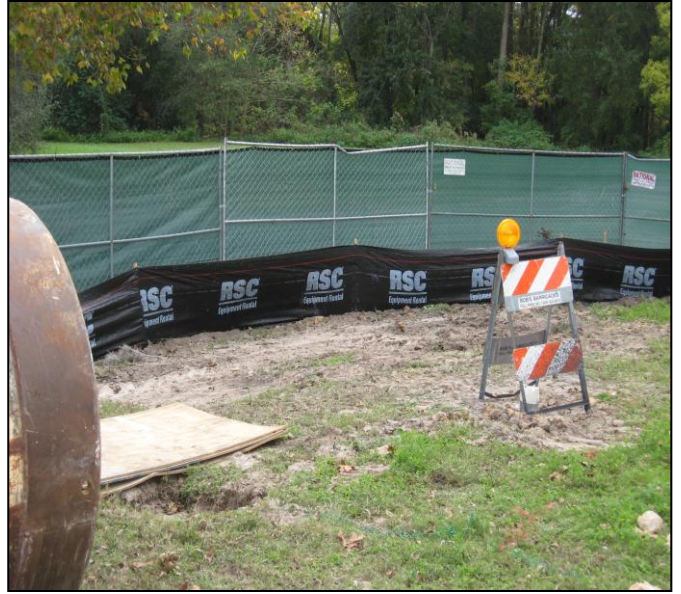
Photograph 6: Silt fence and hay bales are used for stormwater control.

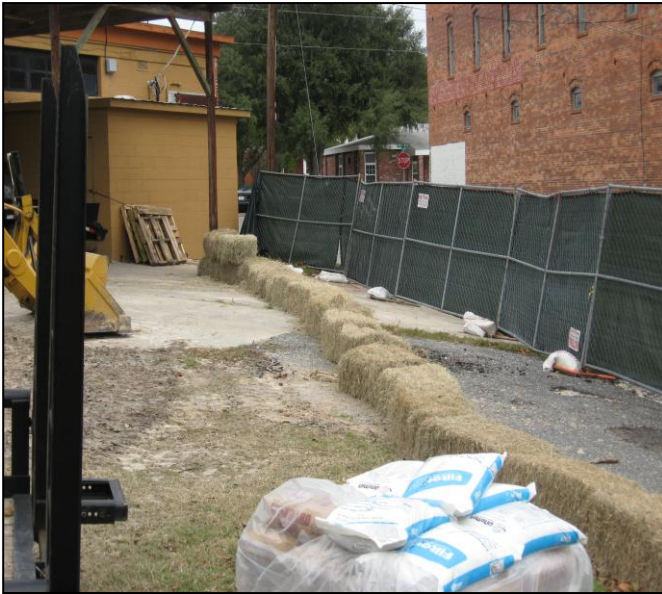
Photograph 7: Silt fence and hay bales are used for stormwater control.
